BACKGROUND

Founders of a large church in south Florida wanted to ensure they were putting the comfort, health and wellbeing of their members and staff, first. With an existing Building Management System monitoring and controlling various sections of the facility, they wanted to integrate emerging technology to improve their occupant's experience.

CASE STUDY

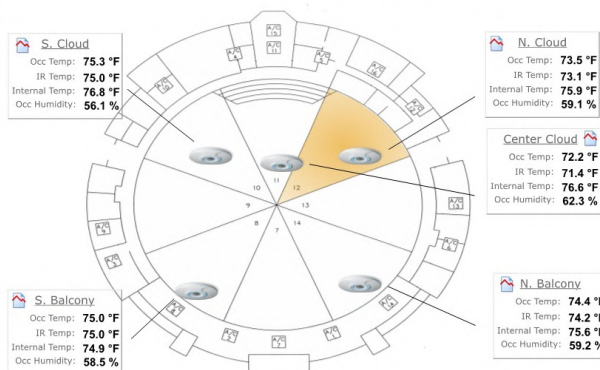
SANCTUARY FLOORPLAN

RTU01 Temp: 68.0 °F Setpoint: 68.0 °F Status: ON Fan Fail: NORMAL	RTU05 Temp: 73.0 °F Setpoint: 72.0 °F Status: ON Fan Fail: NORMAL	RTU09 Temp: 71.4 °F Setpoint: 71.0 °F Status: ON Fan Fail: NORMAL	RTU13 Temp: 69.5 °F Setpoint: 71.0 °F Status: ON Fan Fail: NORMAL	RTU17 SA Temp: 60.0 °F RA Temp: 70.8 °F
RTU02 Temp: 68.1 °F Setpoint: 68.0 °F Status: ON Fan Fail: NORMAL	RTU06 Temp: 68.8 °F Setpoint: 72.0 °F Status: ON Fan Fail: NORMAL	RTU10 Temp: 72.5 °F Setpoint: 76.0 °F Status: ON Fan Fail: NORMAL	RTU14 Temp: 70.7 °F Setpoint: 71.0 °F Status: ON Fan Fail: NORMAL	
RTU03 Temp: 70.7 °F Setpoint: 71.6 °F Status: ON Fan Fail: NORMAL	RTU07 Temp: 72.0 °F Setpoint: 71.0 °F Status: ON Fan Fail: NORMAL	RTU11 Temp: 72.8 °F Setpoint: 76.0 °F Status: ON Fan Fail: NORMAL	RTU15 Temp: 74.7 °F Setpoint: 74.1 °F Status: OFF Fan Fail: NORMAL	
RTU04 Temp: 71.6 °F Setpoint: 72.0 °F Status: OFF Fan Fail: NORMAL	RTU08 Temp: 71.9 °F Setpoint: 71.0 °F Status: ON Fan Fail: NORMAL	RTU12 Temp: 72.8 °F Setpoint: 71.0 °F Status: ON Fan Fail: NORMAL	RTU16 SA Temp: 0.0 °F RA Temp: 0.0 °F

Installing three of the O3 Sense units in the open area of the sanctuary provided the optimal vantage point for more accurate sensing and control of the environment. Air conditioning units in this area were using return air temperature as their process variable, so the three occupant temperatures from the O3 Sense were shared with all the units controlling that area.

O3 Sense were installed over two balcony areas to overcome an overlap in control zones in both the balcony and the lower bowl. The existing air conditioning units had tradition temperature sensors on the wall but located extremely far away from the area they are responsible for controlling.
